# Home Inspection Report

123 Sample St, Fort Worth, TX 76104

Thursday, January 18, 2018

Z-View Inspections, PLLC

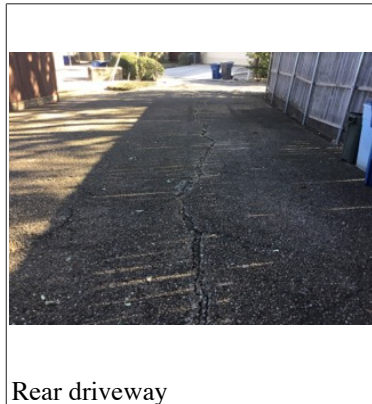
Rear driveway

**Performing as intended on the day of inspection. No significant problems were observed.**

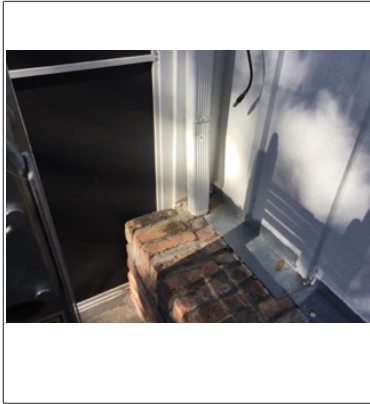
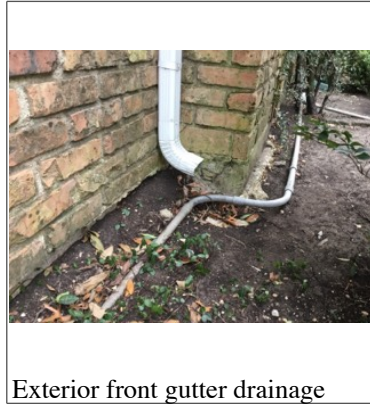
Exterior front gutter drainage

**Gutter downspout on exterior front of house is draining directly beside foundation causing erosion. Recommend extending gutter downspout outward and backfilling soil along foundation.**

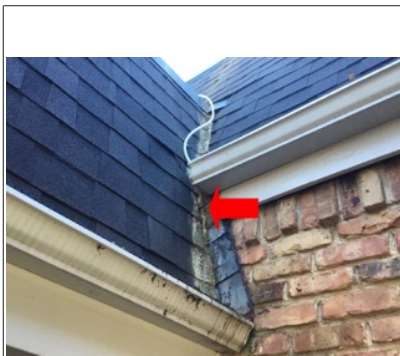
**Gutter downspout needed above front entrance of house. Downspout(s) that discharge onto the roof should be extended to discharge directly into the gutters below. This condition, if left unattended, can result in premature deterioration of the roofing under the end of the downspout.**

Roof covering drainage above front entrance

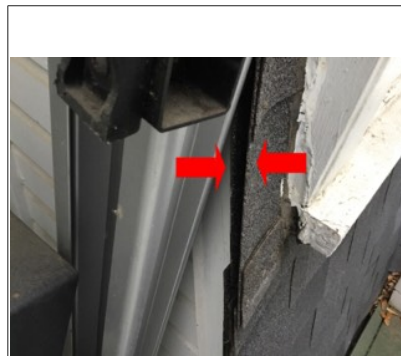
**Roof covering has 2nd layer of asphalt shingles installed over old covering that appear to be performing as intended on the day of inspection.**

2 layers of roof covering

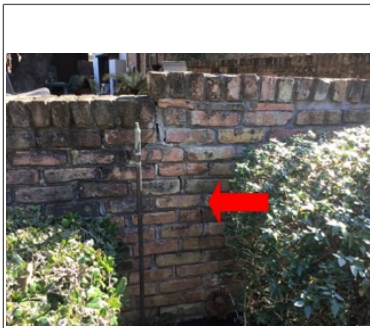
**Front exterior retaining wall has excessive separation on left side with loose brick and mortar no longer securely attached to wall. Recommend contractor to replace or repair as needed.**

Front left exterior retaining wall separation.

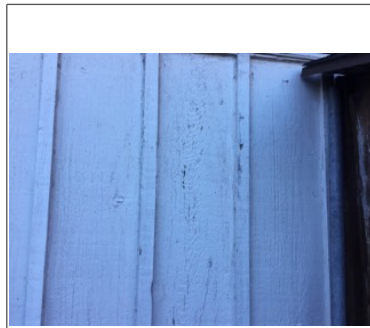
Left side rear exterior wall

**Multiple separations in caulk along multiple exterior windows. Wood siding along rear of exterior has paint flaking and starting to expose wood. As preventive maintenance, recommend caulking all exterior windows and trim as well as applying another coat of paint to wood siding.**

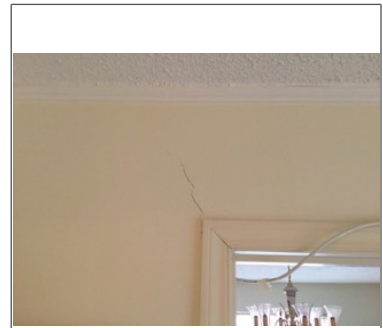
Front left interior room opening

**A few of the interior door openings have minor cracks in the drywall above and appear to be mostly cosmetic as no other structural movement indicators were observed.**

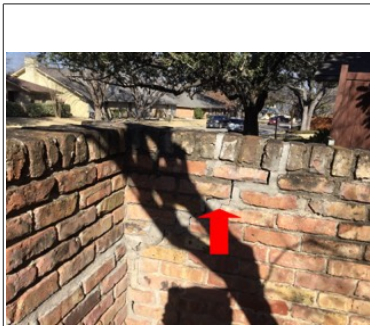
Adjacent side of front left retaining wall.

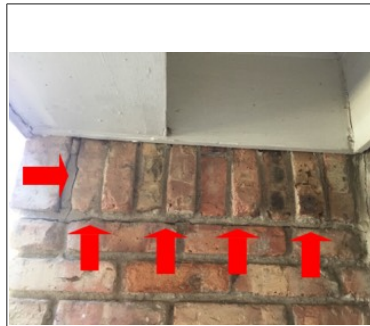
**On the exterior of front entrance, the left side has a set of bricks that have separated and are loose from the wall structure. Recommend contractor to replace or repair as needed.**

Left side front entrance separation

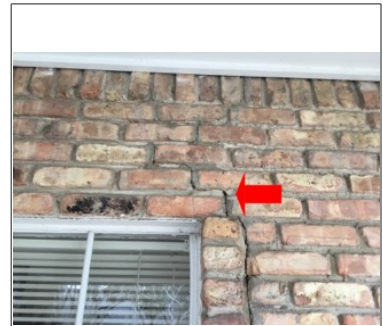
**Minor step cracking present along front exterior window right side of entrance.**

Front exterior window right side of entrance

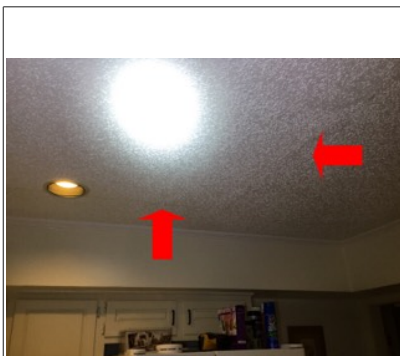
Previous repairs present in multiple locations of ceilings with no moisture present when using moisture meter. One old moisture stain was observed in master bedroom ceiling with no active moisture present. Ceilings and floors appear to be performing as intended on day of inspection.

Previous repair present kitchen ceiling

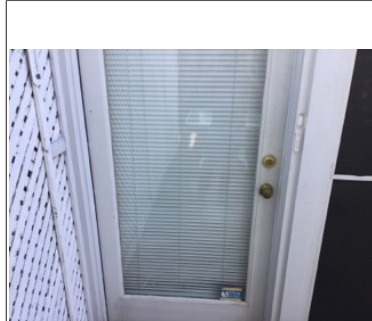
Rear exterior entrance door

**Safety glazing not present on rear entry door. Recommend replacement as this door location is considered a hazardous location for the purpose of glazing.**

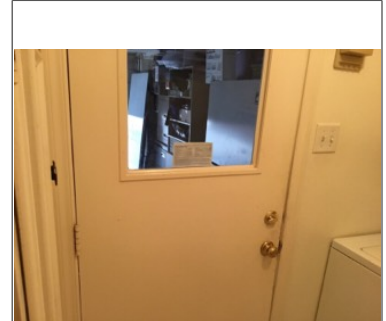
Door to garage

Fixed glass panel in door to garage does not appear to be fire rated and comply with fire separation between interior of the house and the garage. Recommend replacing with a solid core or an appropriate fire rated door.

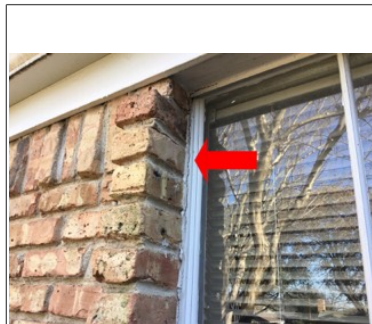
Caulk separation front left exterior window

**As preventive maintenance, recommend applying caulk to all exterior windows and trim. Windows performing as intended on day of inspection.**

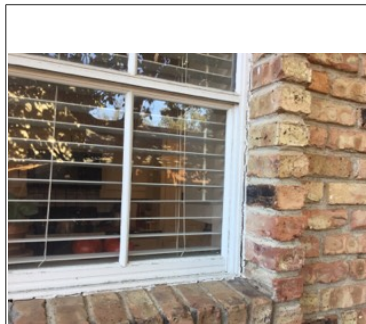
Separation left side exterior window

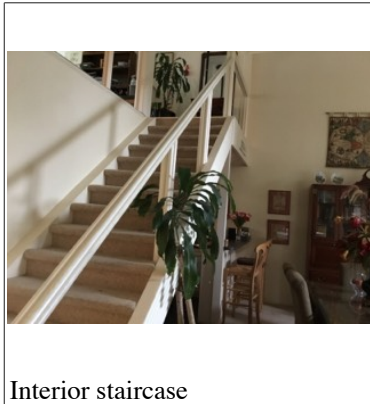
**areas, balconies and porches should have intermediate rails or ornamental closures which do not allow passage of an object more than 4-inches. Recommend a qualified contractor repair or replace as needed as this is a safety concern.**

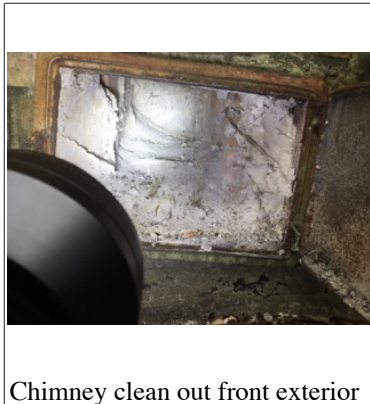
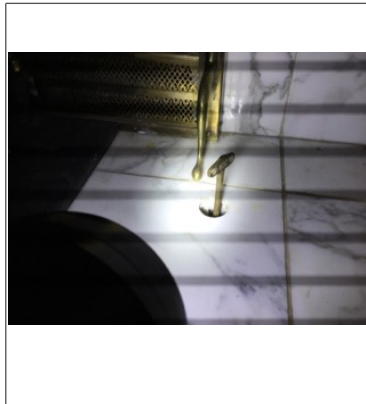
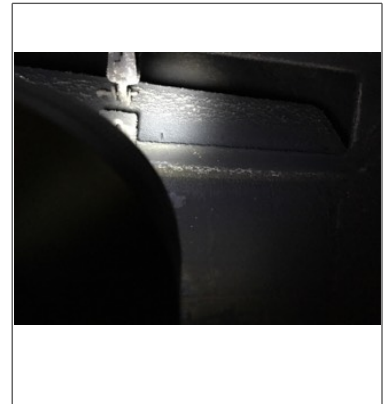
**No C-clamp present on gas fireplace. Recommend installing C-clamp and removing debris from exterior chimney clean out.**

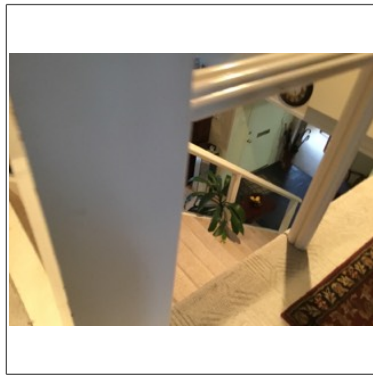
**building standards the required guardrails on open sides of stairways, raised floor areas, balconies and porches should have intermediate rails or ornamental closures which do not allow passage of an object more than 4-inches. Recommend a qualified contractor repair or replace as needed as this is a safety concern.**

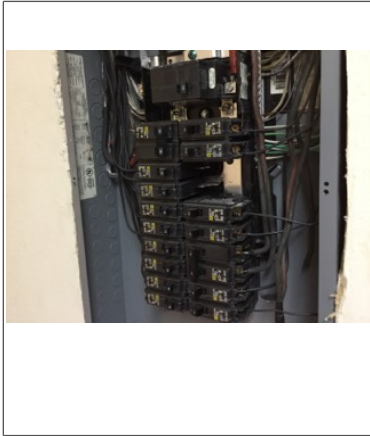
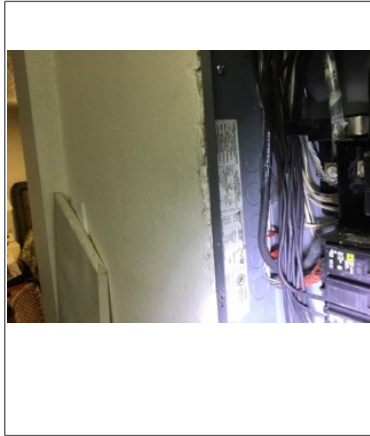
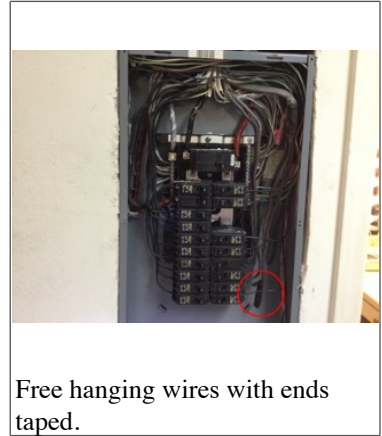
**Aluminum wiring present within the branch circuits of the panel which could potentially be a fire hazard. Recommend evaluation by a qualified electrician who is experienced in evaluating and correcting aluminum wiring problems.**

Free hanging wires with ends taped.

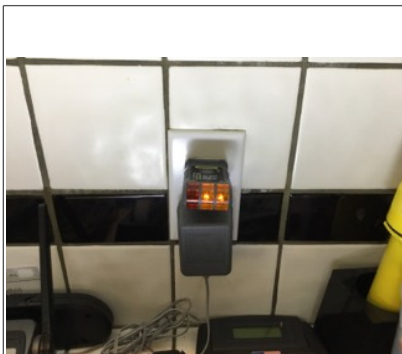
**GFCI outlets are only present in main bathroom. The installation of a ground fault circuit interrupters (GFCI) are recommended in all kitchen, bathroom, garage, and exterior outlets. A ground fault circuit interrupter (GFCI) offers protection from shock or electrocution.**

Kitchen receptacles not gfc  
protected

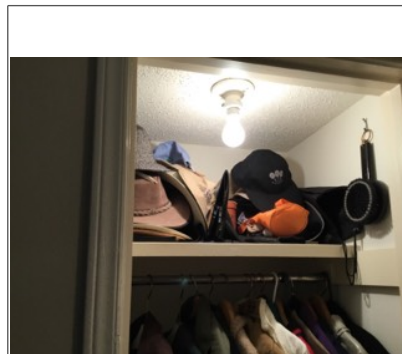
Front entry closet

**Recommend replacing existing bare bulb lights in closets with lights that have globes enclosing the bulb to eliminate any potential electrical hazard.**

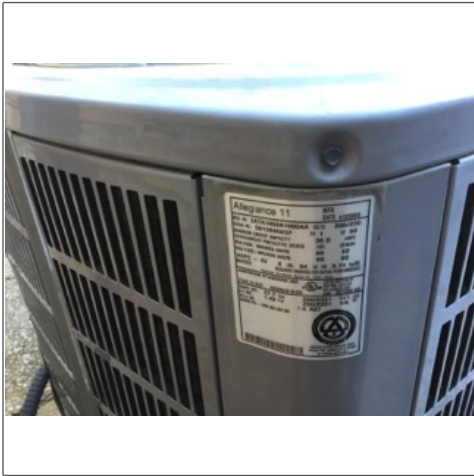
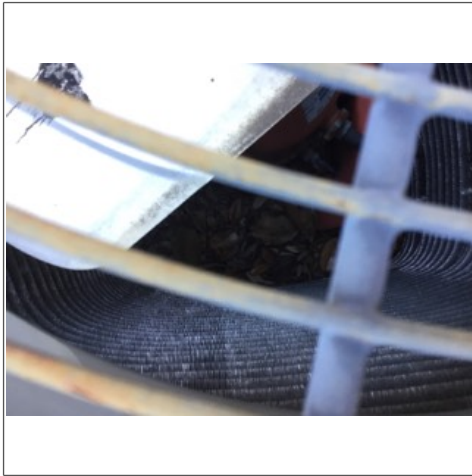
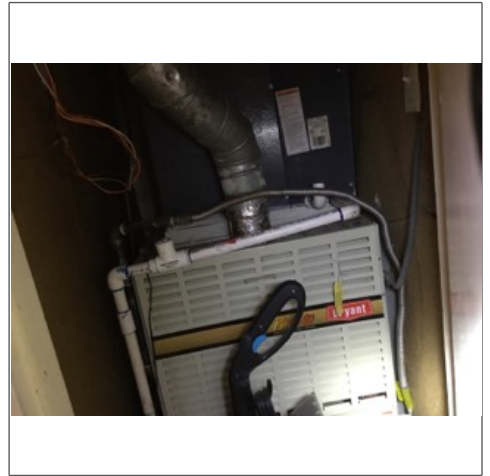
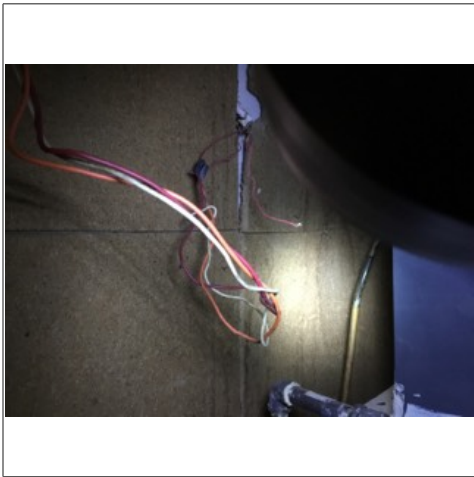
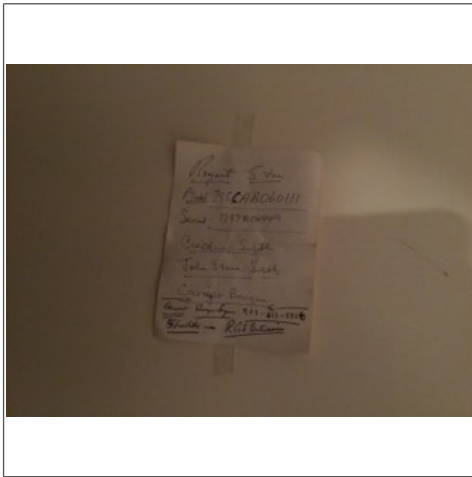
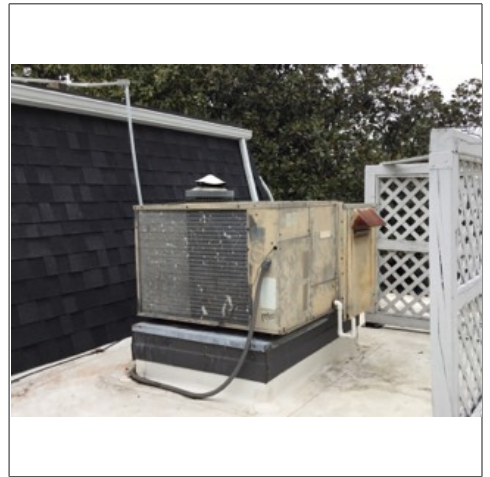
**Bryant furnace equipment is 21 years old. While performing as intended on the day of inspection, it has surpassed its useful service life and recommend replacement by a qualified HVAC contractor.**

**Exposed electrical wiring hanging freely in furnace closet. Recommend a qualified contractor evaluate and repair as needed for safety reasons.**

**Due to the age and installation technique of air conditioner, recommend HVAC contractor to further**

**evaluate and recommend replacement as needed.**

**Exterior condensing unit has an excessive amount of debris inside. Recommend removing debris.**

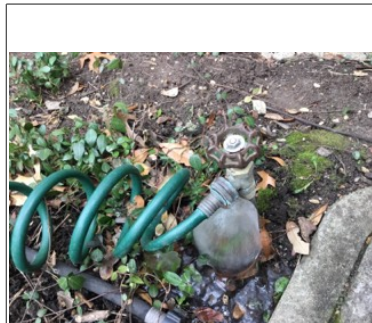
Front exterior hose bib

**Exterior hose bibs do not have anti siphon devices installed. Recommend installing anti siphon devices on all exterior hose bibs.**

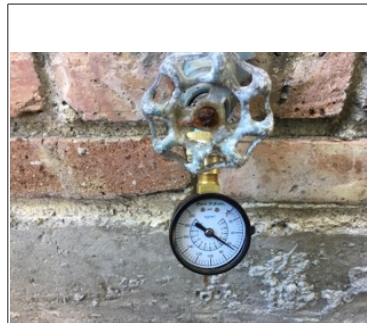
Left side exterior hose bib no anti siphon device present

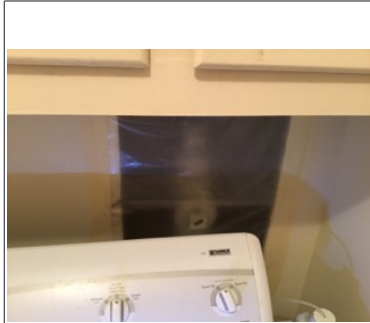
Access Cutout in laundry room wall

**Laundry room had access cutout covered with plastic. Recommend contractor remove plastic, evaluate components in the access cutout, and make recommendations as needed.**

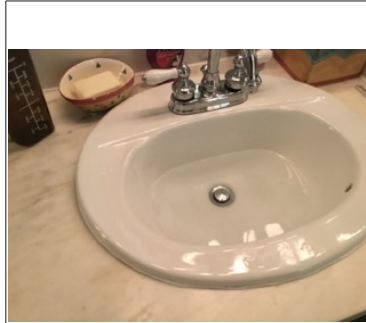
Master bath sink

**Master bathroom sink drainage extremely slow. Recommend plumbing contractor evaluate and repair as needed. All other sinks and tubs drainage performed as intended.**

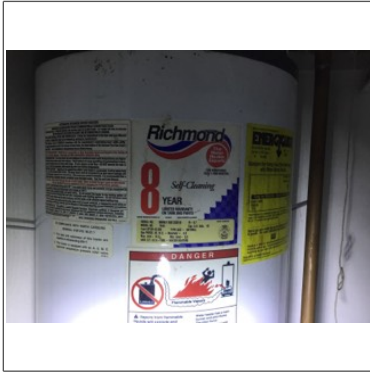
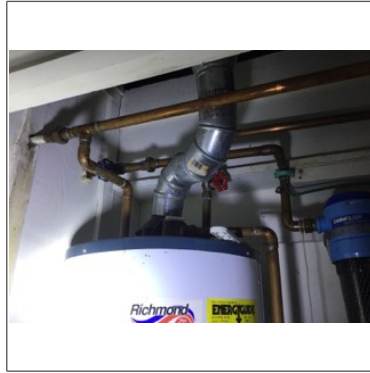
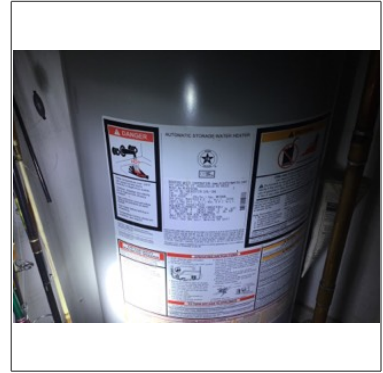
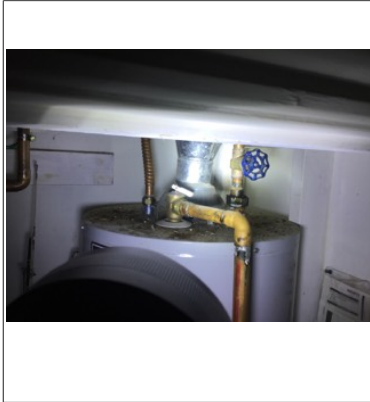
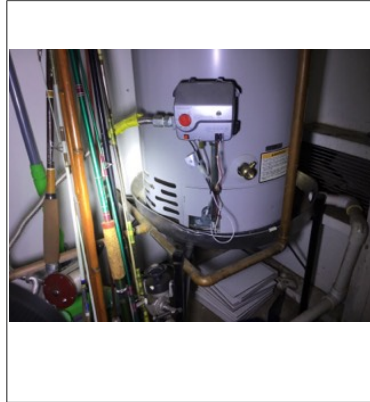
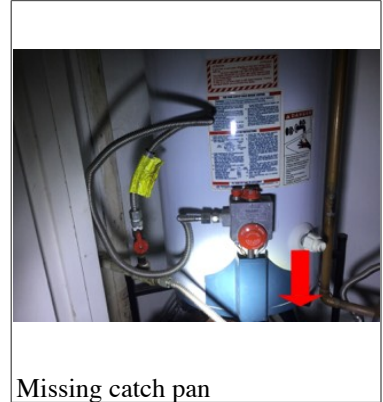
**The Richmond water heater in the left side of the closet is a 20 year old unit. As it is performing as intended, it has also surpassed its useful service life. The drain pan is missing, and the installation of one is recommended.**

Missing catch pan

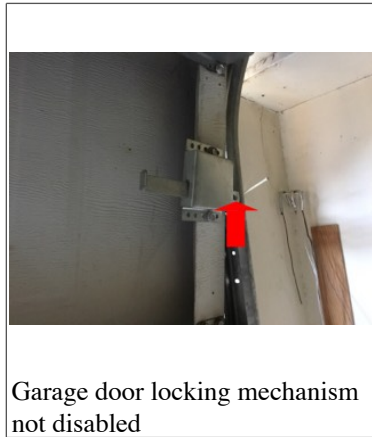
**Garage door locking mechanism should be disabled to prevent possible damage to door when using automatic opener.**
